## SERVICE BULLETIN

N° **169-148**

# EMERGENCY ALERT

**ATA 64 - TAIL ROTOR FLIGHT CONTROL IMPROVED PERIODICAL INSPECTION**

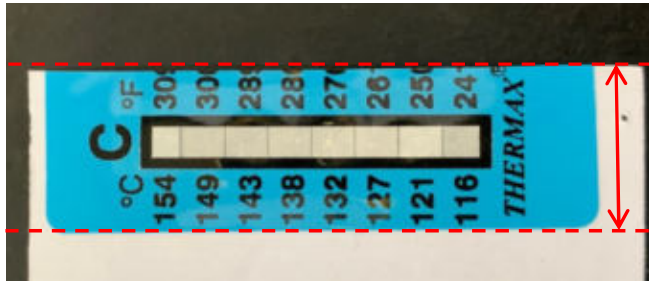
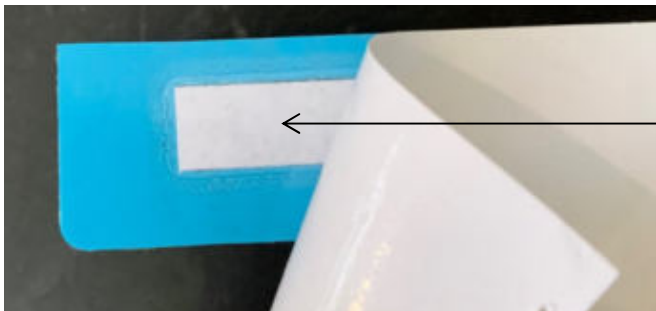
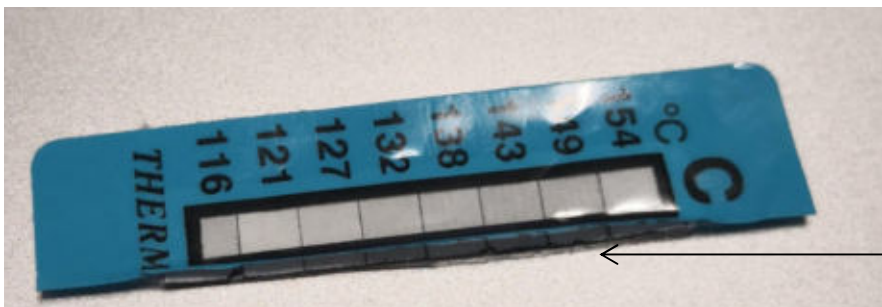
**Figure 5**

Cutting line. Pay attention to not cut the degree Celsius scale.

Limit cutting at the minimum required to obtain 16mm of height.

Pay attention to not damage or to expose to the environment the sensitive elements.

Do not use a thermal strip if after having trimmed it, its sensitive element is exposed to air. See below an example of a badly cut strip.

Thermal strip layers delamination.  
NOT acceptable.

If thermal strip trimming is required, confirm that the cut did not cause debonding of strip layers.

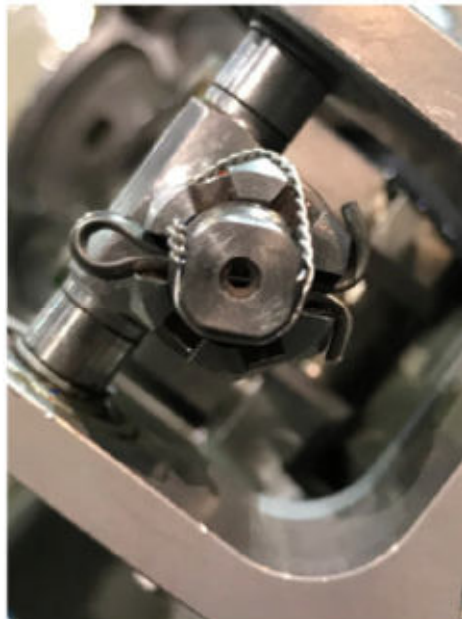
Figure 2

1. Take a picture of the castellated nut (60) area of the Tail Rotor Actuator seen from the input lever (110) side (see Fig. 2 below for reference):

2. Check the paint mark for absence of evidence of rotation between the parts. **Record the result of the check** in the template provided at the end of this Service Bulletin.

If castellated nut (60) is loose then contact Leonardo Helicopters for further instructions.

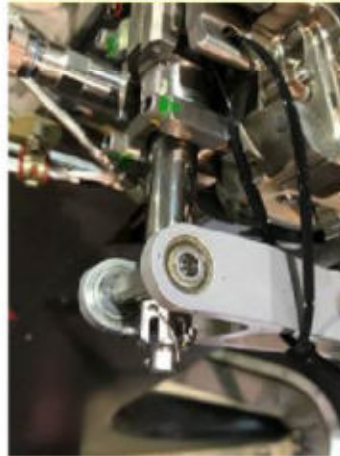
Figure 3

2. Apply tie rap on the input lever (110) as per Fig. 3.

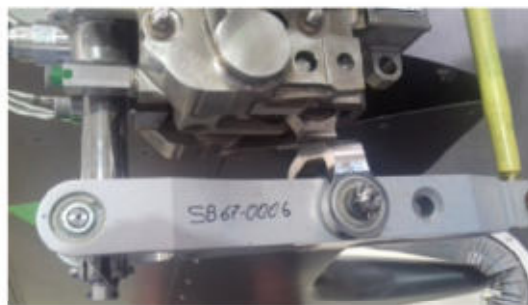
Figure 5

14. Mark "SB 67-0006" on the input lever (110) with permanent ink pen as per Fig. 5.
